NASA Technical Memorandum TM 107552

Debris/Ice/TPS Assessment And Integrated Photographic Analysis For Shuttle Mission STS-46

September 1992

Gregory N. Katnik
NASA/Kennedy Space Center

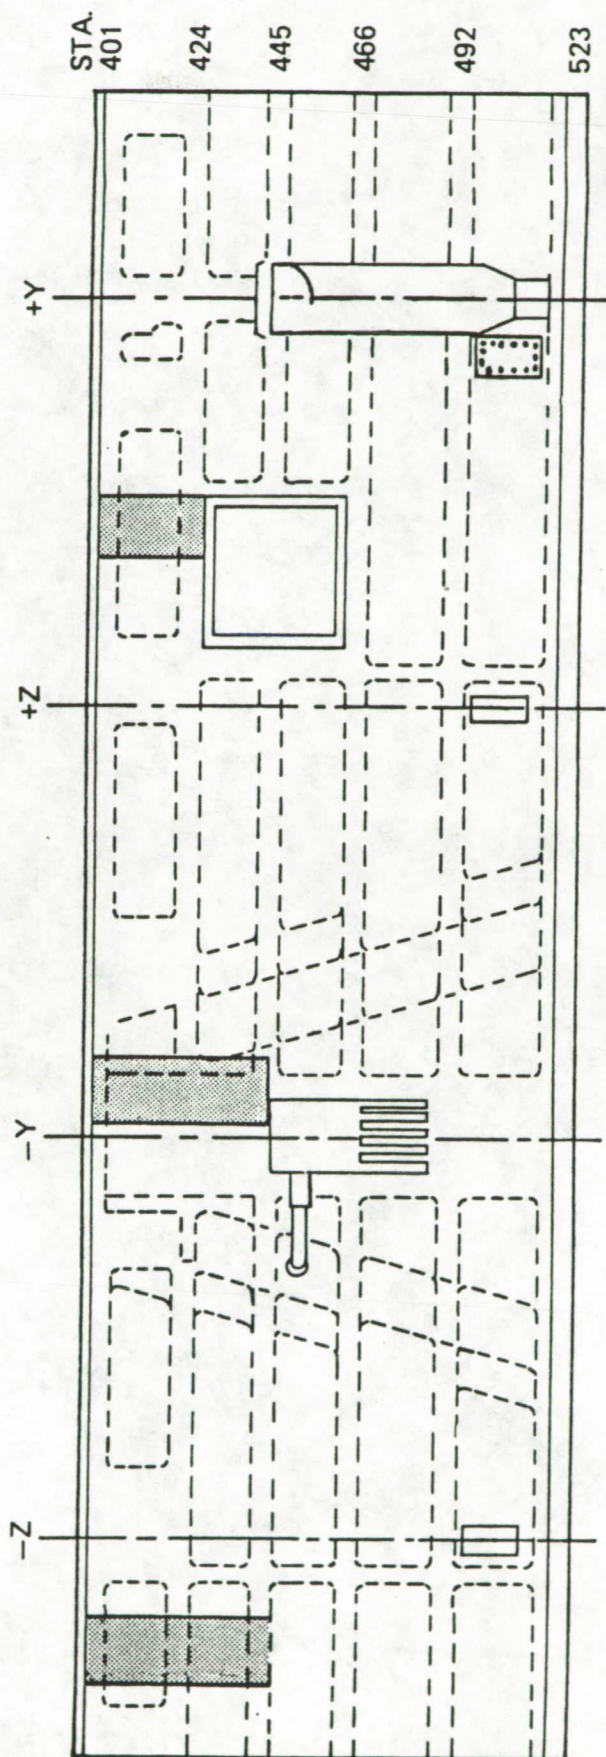
Figure 5. RIGHT SRB FWD SKIRT

The RH forward skirt exhibited no debonds or missing TPS. Both RSS antennae were intact and undamaged. Minor blistering of the Hypalon paint occurred on the systems tunnel cover and forward ET/SRB attach point (Figure 5). No pins were missing from the frustum severance ring. The forward separation bolt and electrical cables appeared to have separated cleanly.

TPS MISSING
NONE

DEBONDS
NONE

MINOR BLISTERING OF
HYPALON PAINT ON
SYSTEMS TUNNEL COVER
AND ET/SRB ATTACH POINT

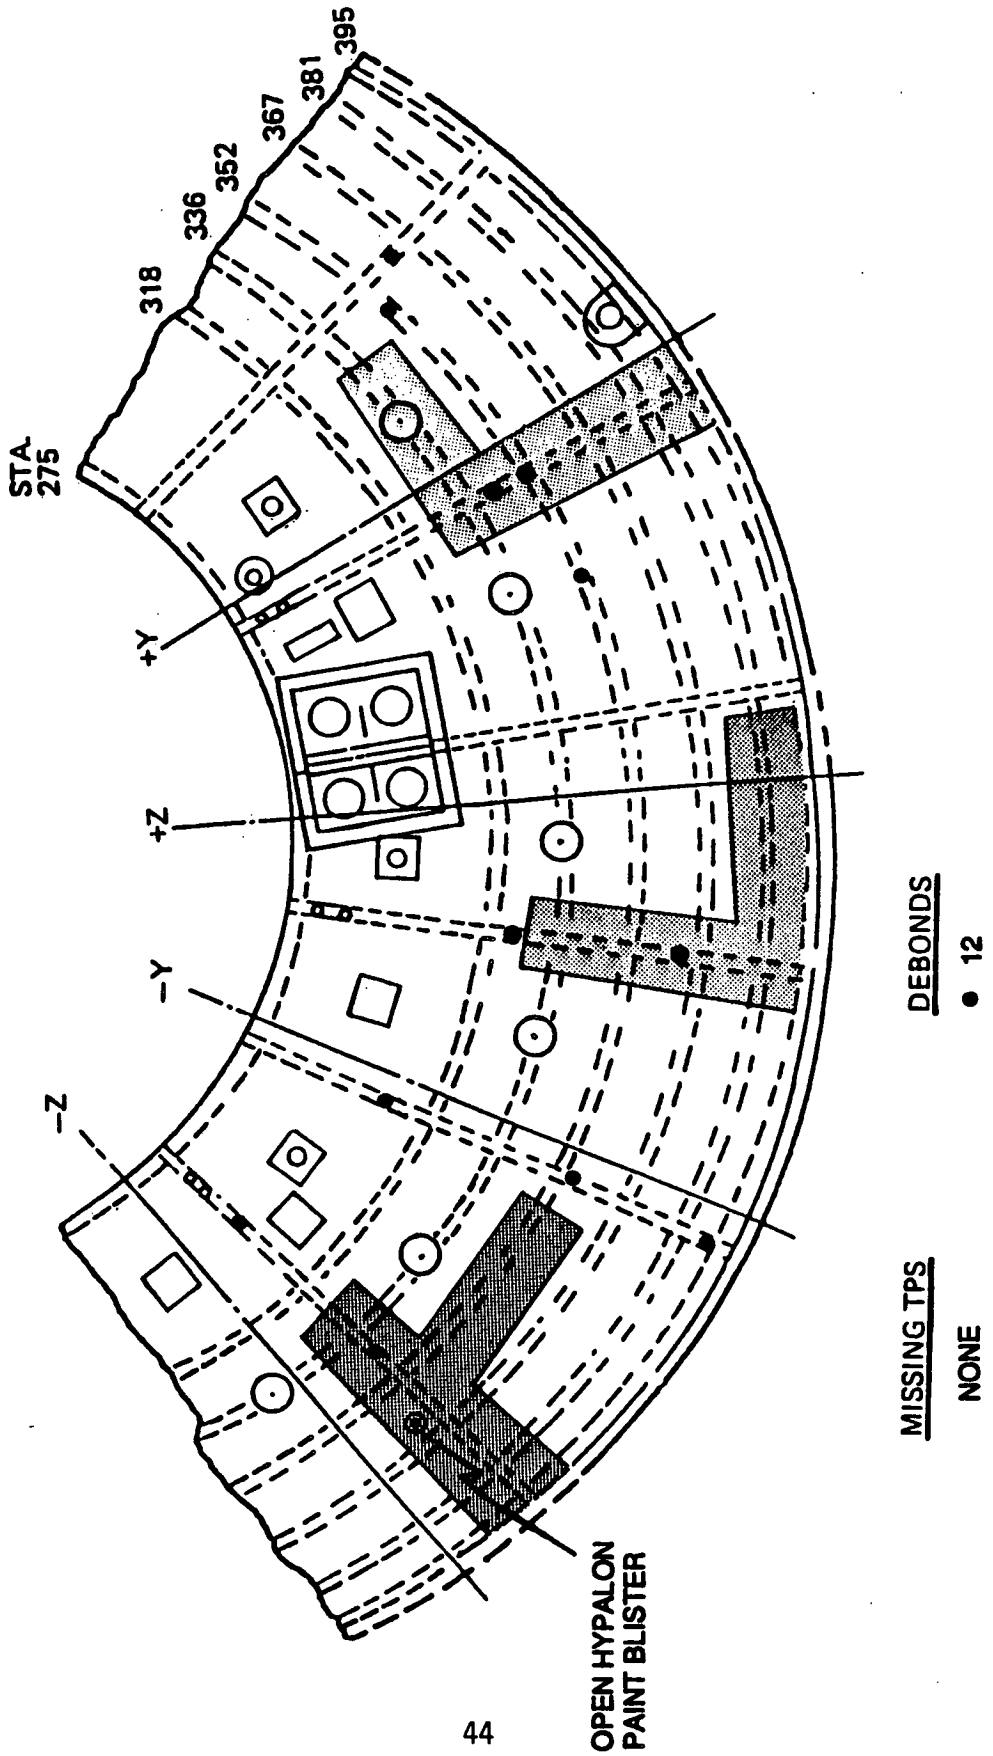
Figure 7. LEFT SRB FRUSTUM

The LH frustum was missing no TPS but had 12 MSA-2 debonds over fasteners. There was very minor localized blistering of the Hypalon paint in isolated areas. The BSM aero heatshield covers were locked in the fully opened position (Figure 7).

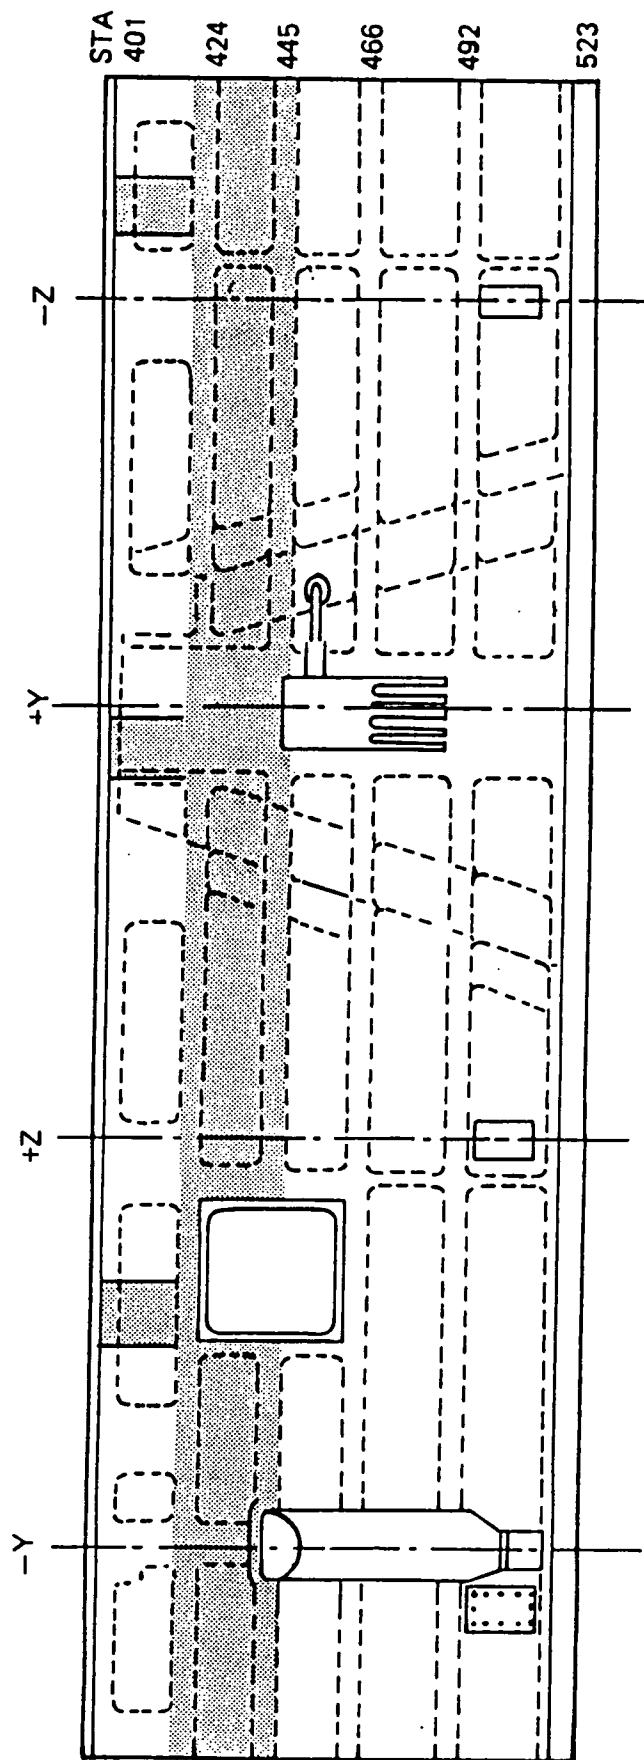
Figure 8. LEFT SRB FWD SKIRT

The LH forward skirt exhibited no debonds or missing TPS. The phenolic plates on both RSS antennae were intact. The forward separation bolt and electrical cables appeared to have separated cleanly. No pins were missing from the frustum severance ring. Minor blistering of the Hypalon paint occurred around the ET/SRB attach point (Figure 8).

TPS MISSING

NONE

MINOR BLISTERING OF
HYPALON PAINT ON
ET/SRB ATTACH FITTING

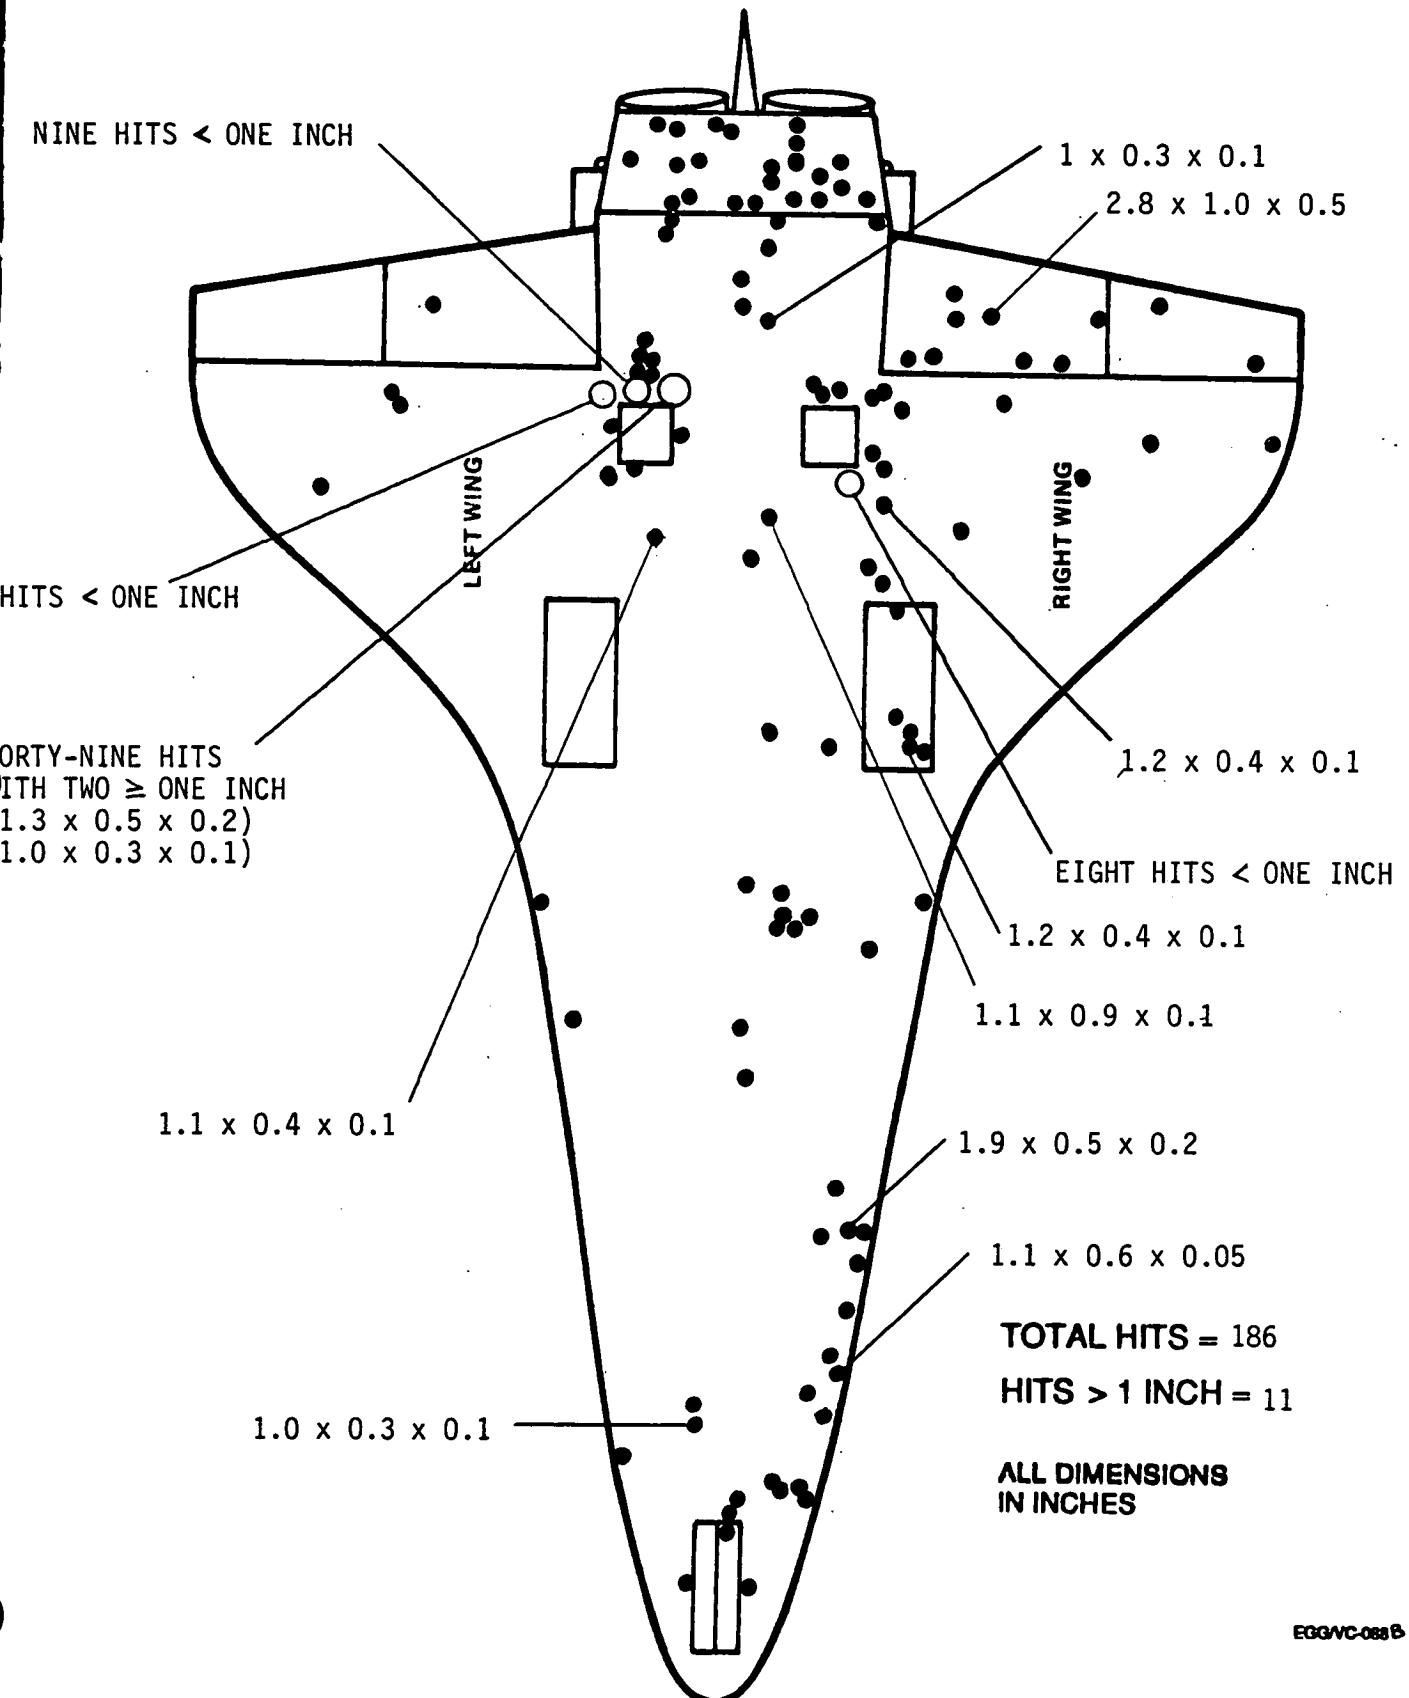
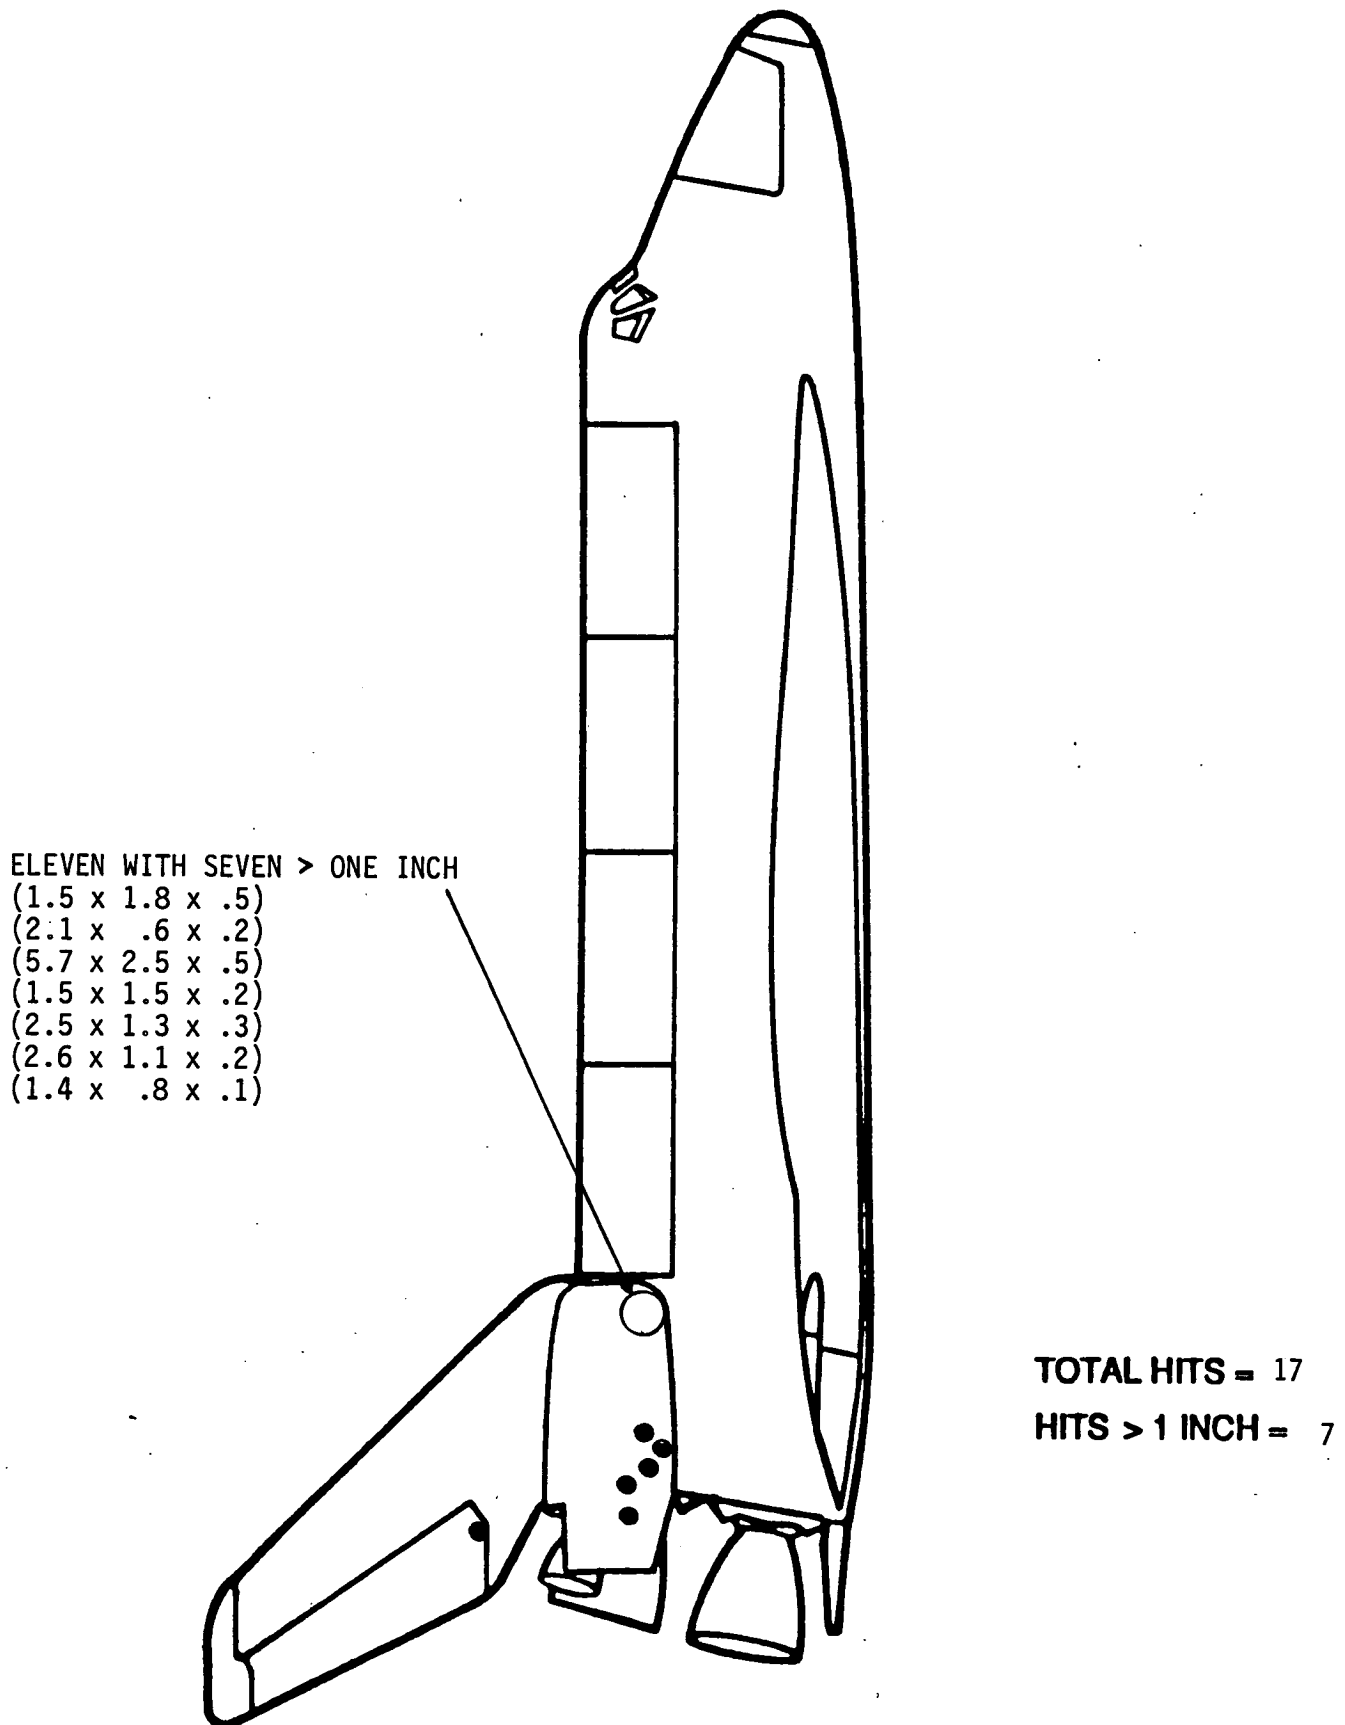
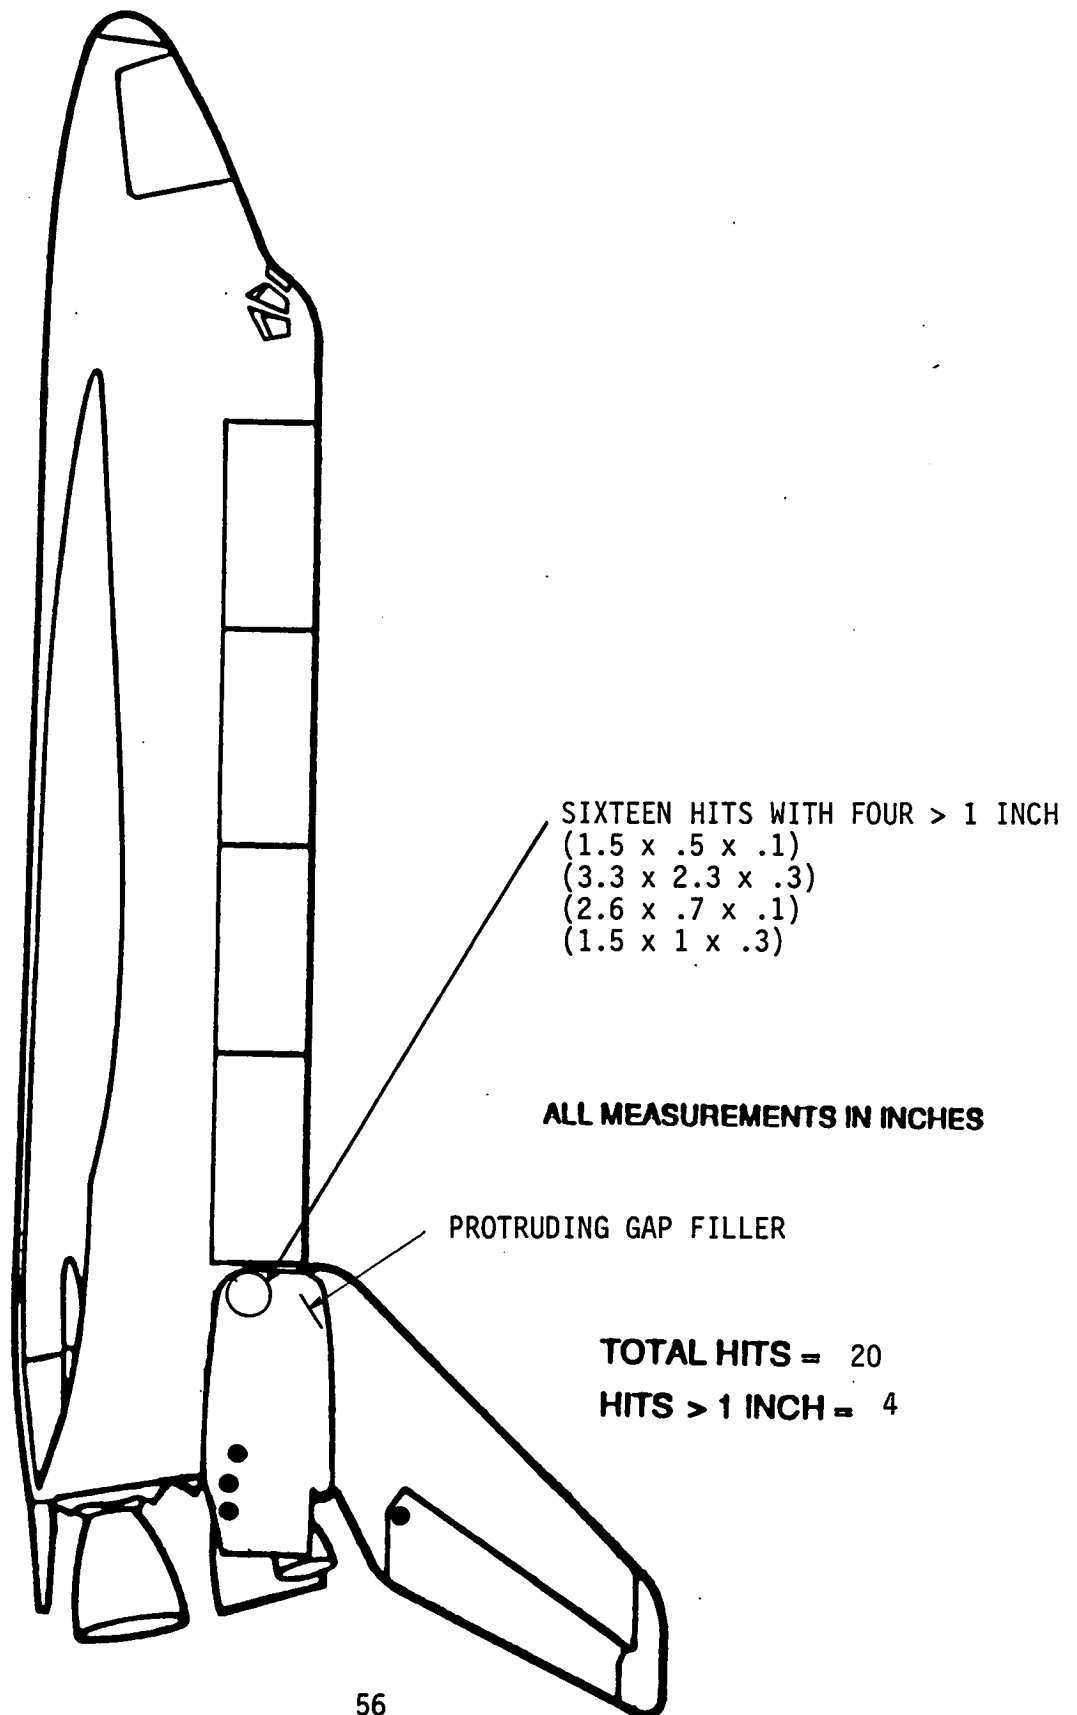
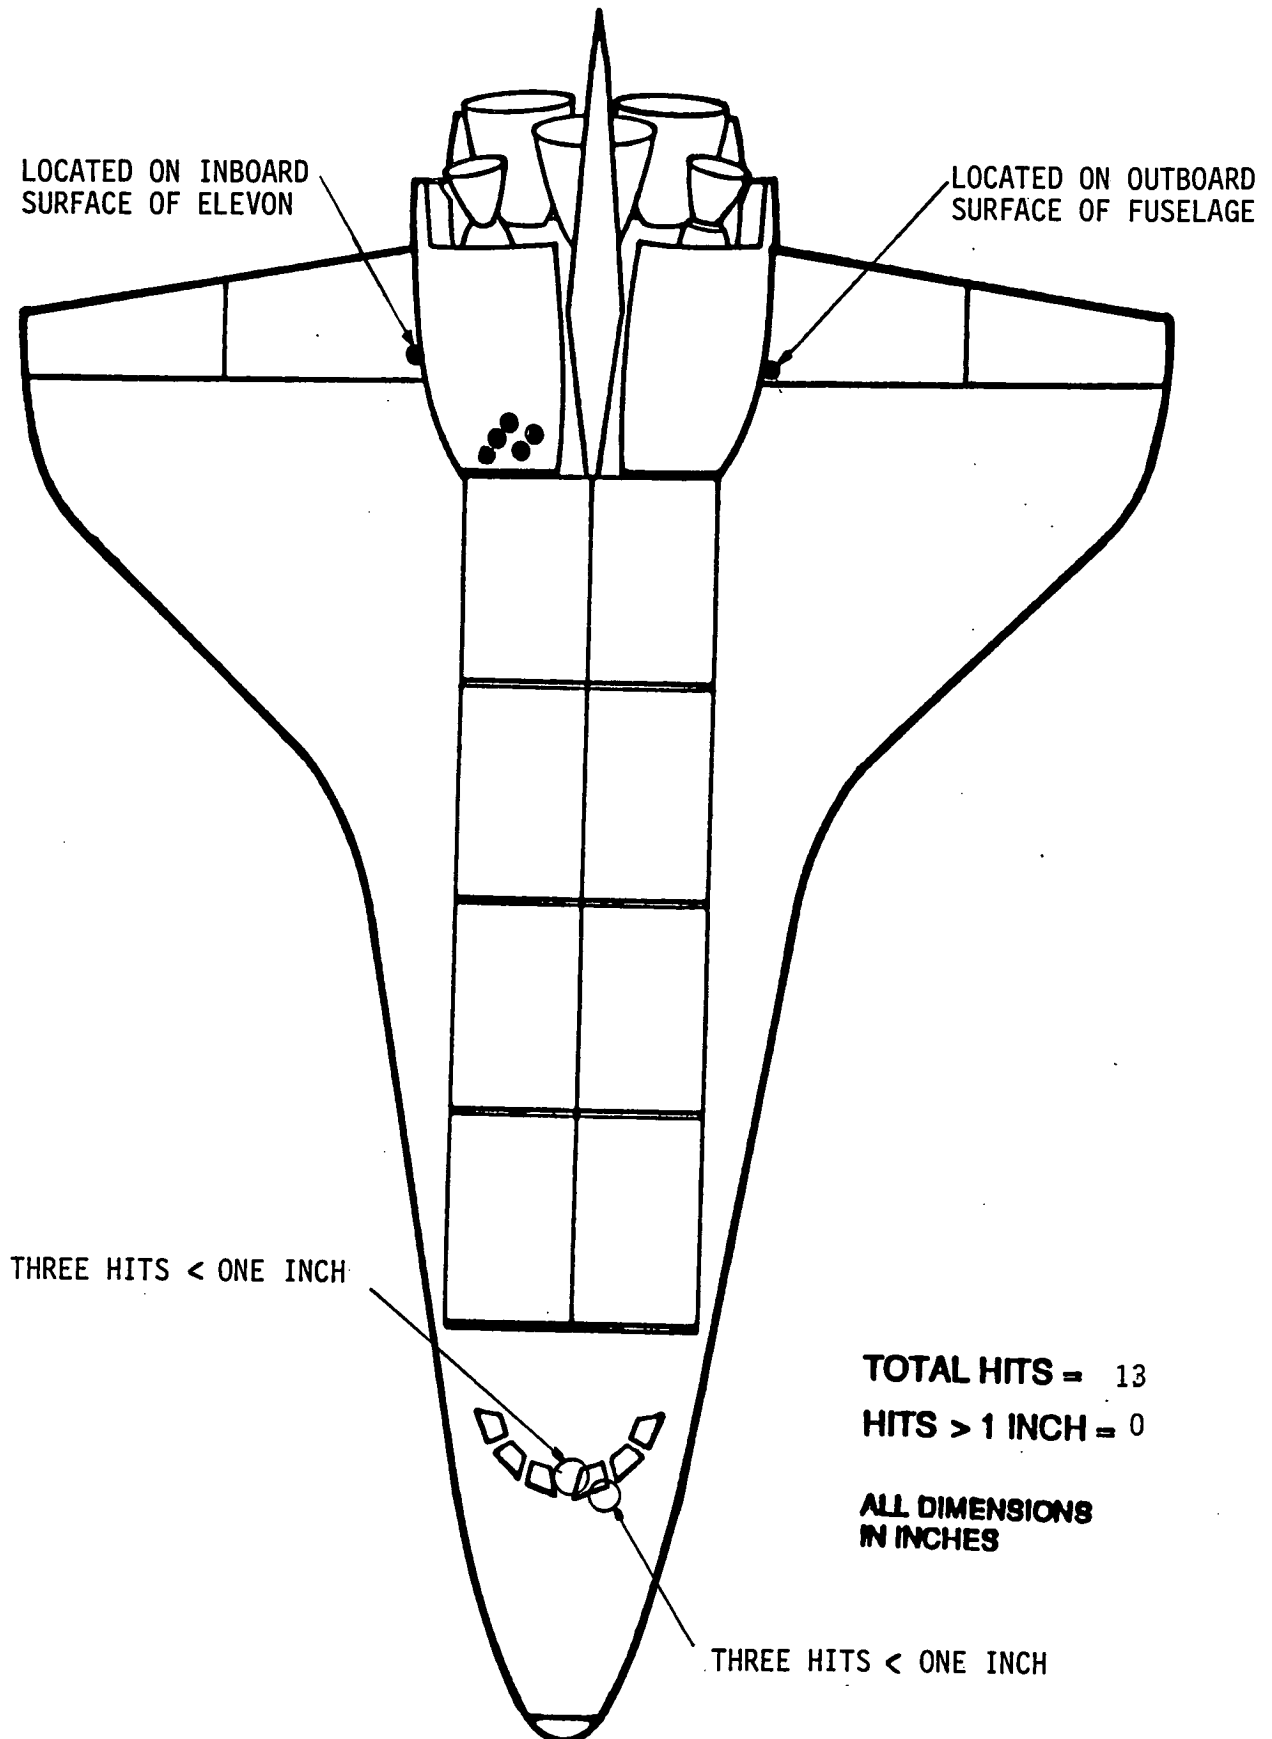
Figure 10. **DEBRIS DAMAGE LOCATIONS**

A detailed post landing inspection of OV-104 (Atlantis) was conducted on 8 August 1992. The Orbiter TPS sustained a total of 236 hits, of which 22 had a major dimension of one inch or greater. The Orbiter lower surface had a total of 186 hits, of which 11 had a major dimension of one inch or greater. Based on these numbers and comparison to statistics from previous missions of similar configuration, the total number of Orbiter TPS debris hits was greater than average and the number of hits one inch or larger was average. No flight hardware was found during the post landing runway inspection or under the ET/ORB LH2 and LO2 umbilicals. All ORB/ET separation devices operated properly.

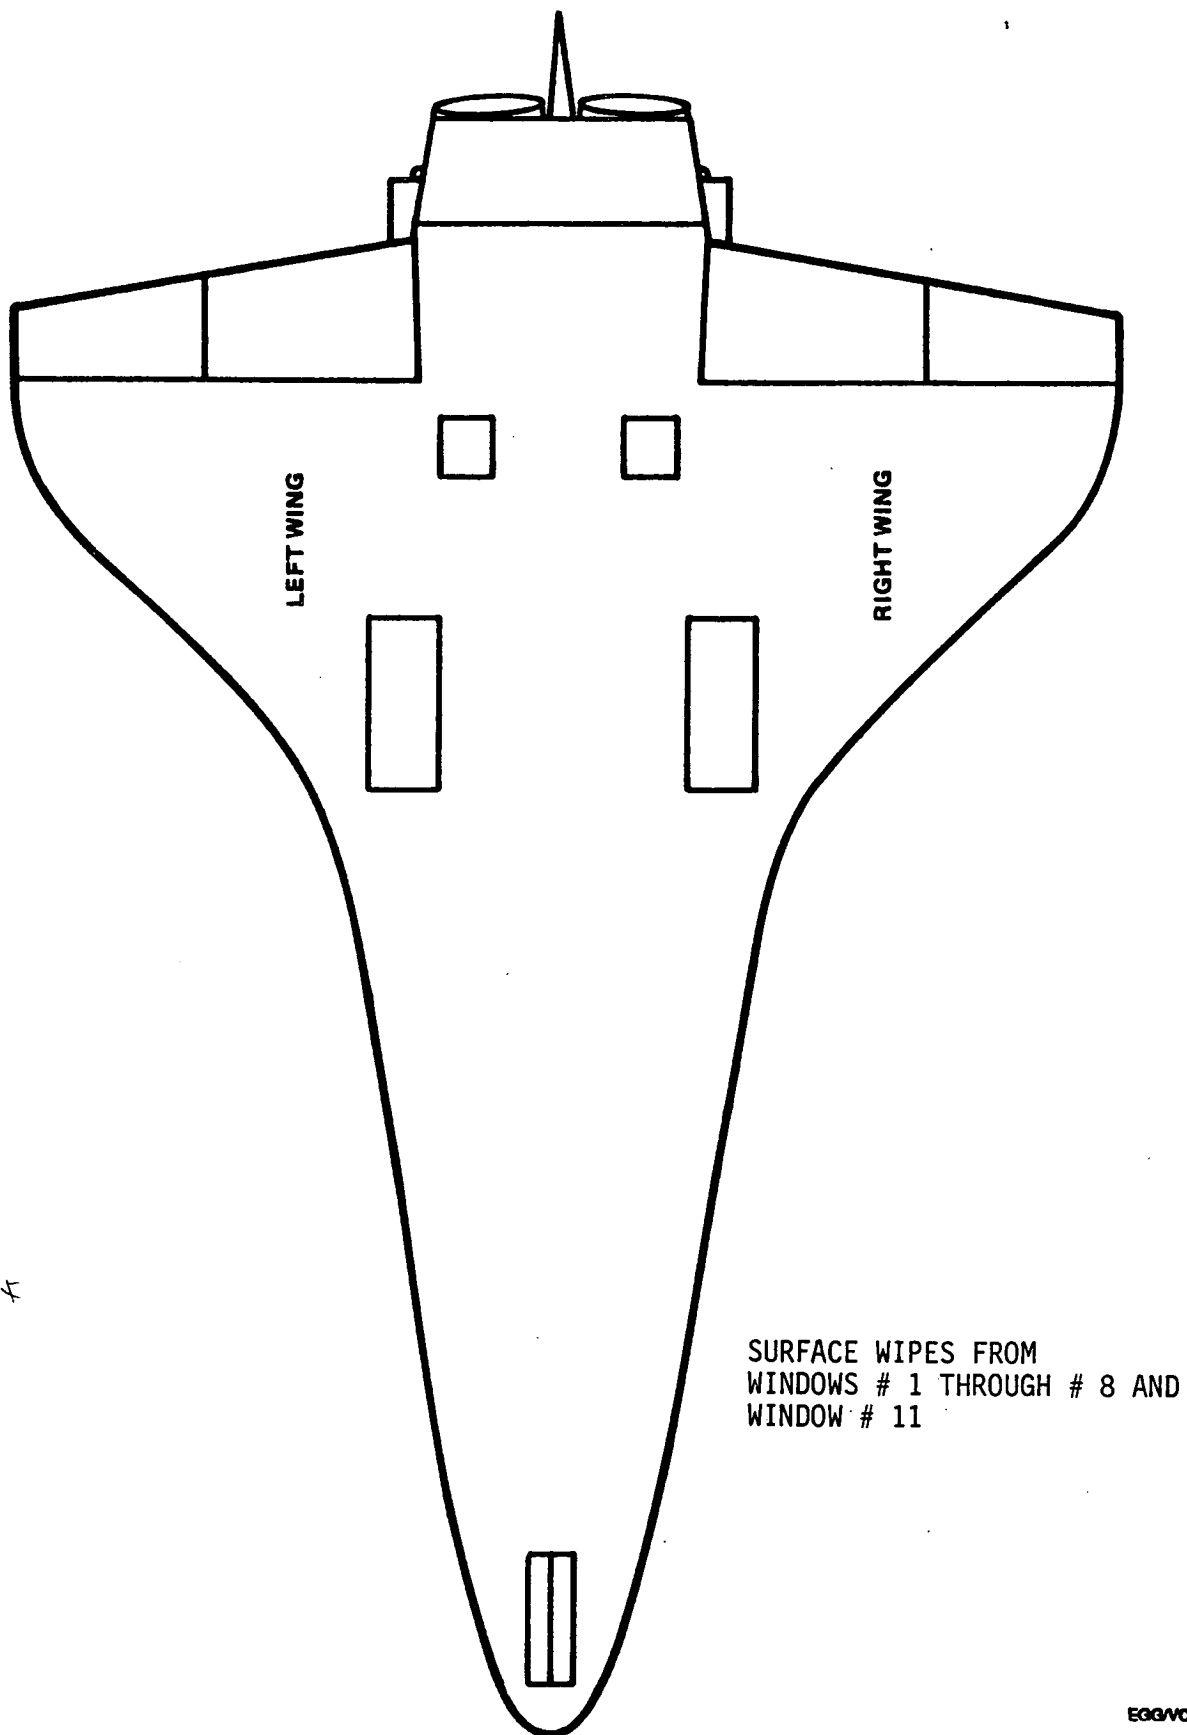
Figure 14. **CHEMICAL SAMPLE LOCATIONS**

Orbiter windows #3 and #4 exhibited moderate hazing with a few streaks. Hazing on the other windows was less than usual. Laboratory analysis will be performed on samples taken from the windows (reference Figure 14). Six damage sites were noted on the perimeter tiles around window #3. The impact sites were only surface coating losses or were no more than 1/4 inch deep. This damage may have been caused by the RTV used to bond paper covers to the FRCS nozzles or by exhaust products from the SRB booster separation motors.
